# FIELD FLOOR IMPACT SOUND ISOLATION

**BUILT IT ECO ACOUSTIC TESTING  
13 CARRINGTON ST, PALMYRA APARTMENTS**

17<sup>th</sup> December 2019

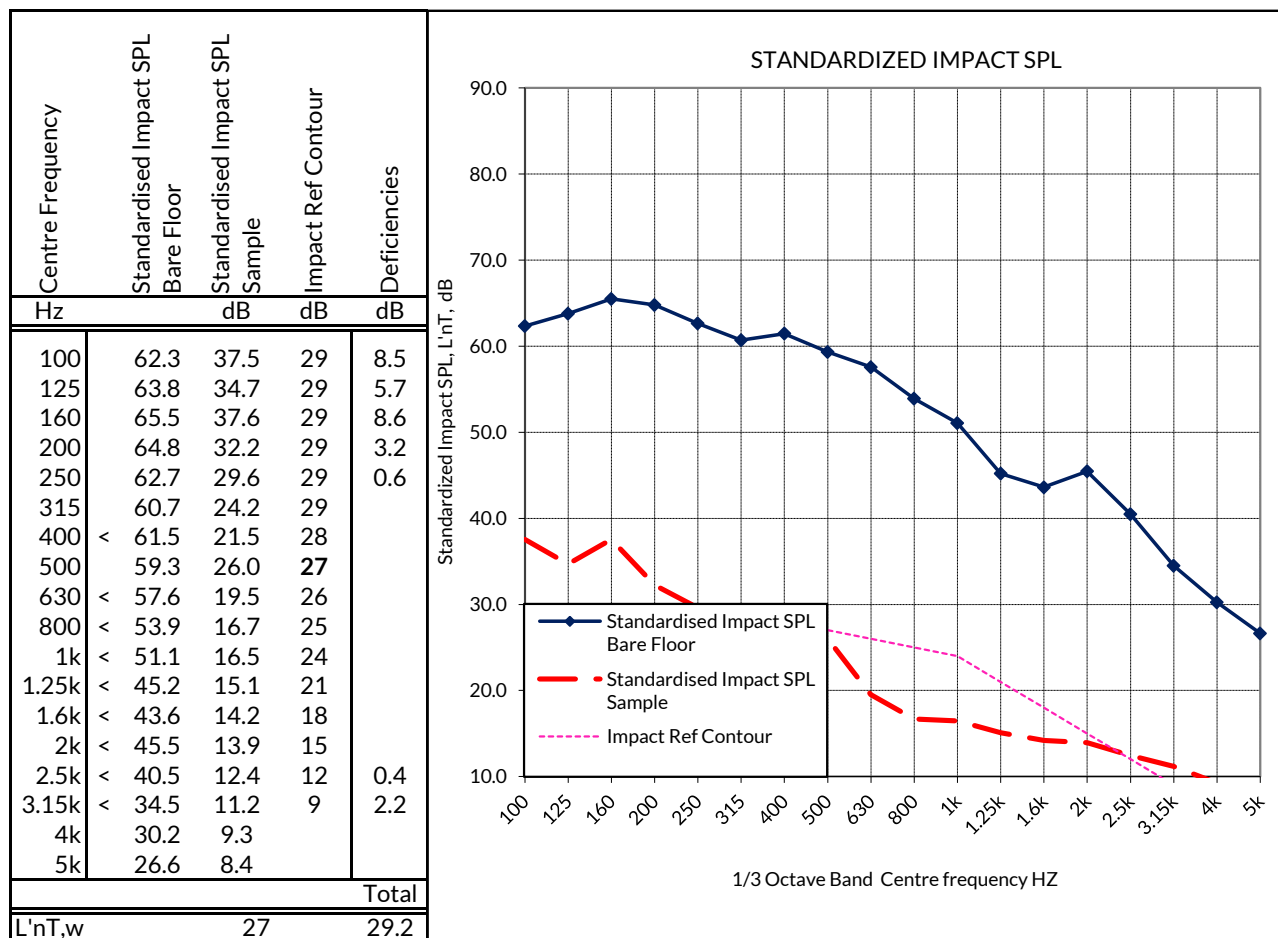
**Project No:** 19-086  
**Project:** BuilditEco Acoustic Testing  
**Client:** BuilditEco  
**Task:** Sample Impact Testing  
**Details:** Carpet on Underlay

Carpet sample  
 Underlay

53mm Supafloor Panel Flooring  
 240mm timber smart joist - R4.0 insulation in cavity  
 70mm resilient mounts  
 1 x 16mm firerated flush plasterboard

Carpet on Underlay

**L'nT,w** 27  
**C<sub>i</sub>** 1

Bare Floor

**58**  
**-1**

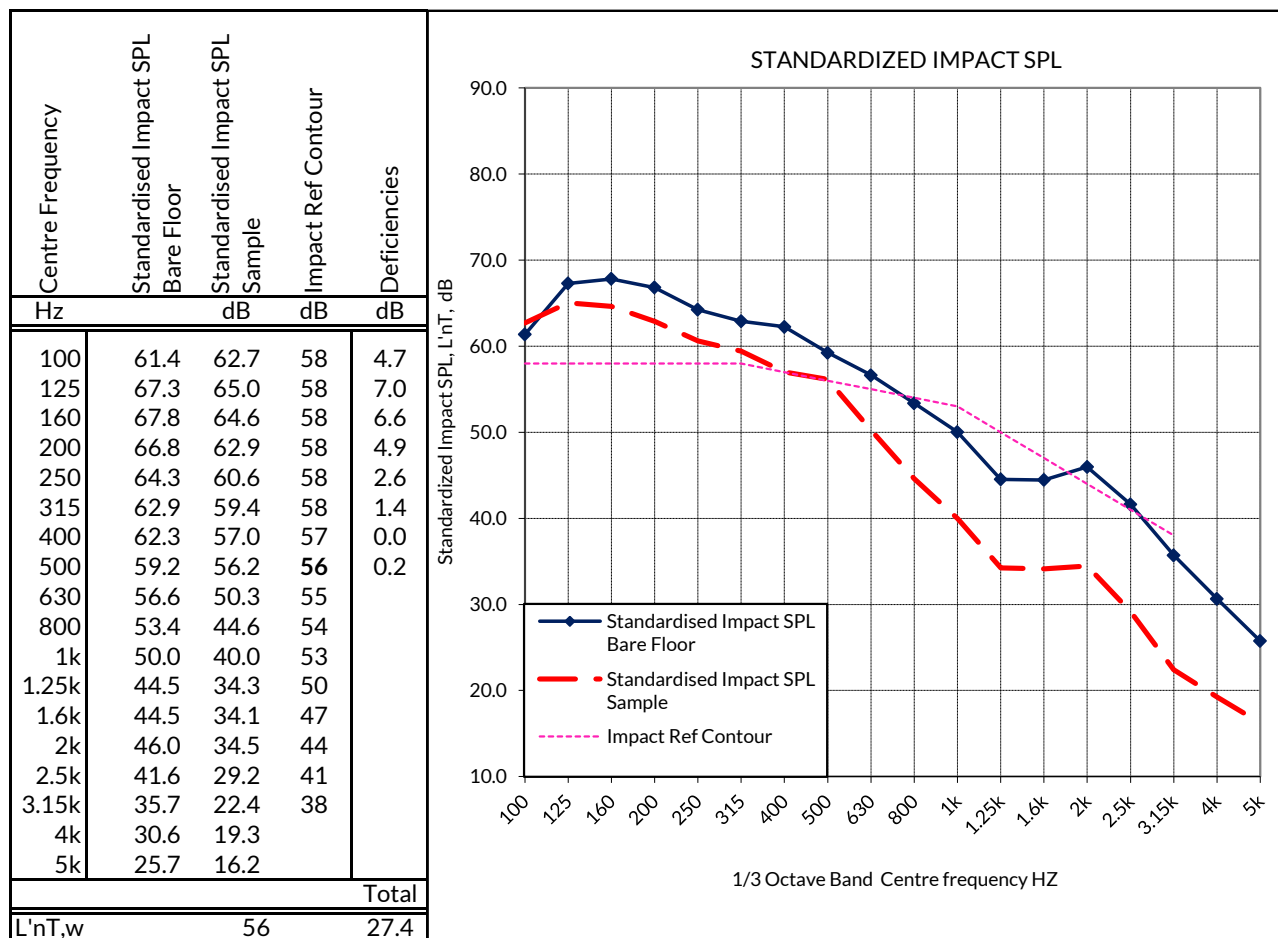
**Project No:** 19-086  
**Project:** BuilditEco Acoustic Testing  
**Client:** BuilditEco  
**Task:** Sample Impact Testing  
**Details:** Floating Timber on 3mm A-mat

Engineered Timber Floor Boards  
No adhesives  
3mm Acoustimat underlay  
Adhesive - 10mm notched trowel

53mm Supafloor Panel Flooring  
240mm timber smart joist - R4.0 insulation in cavity  
70mm resilient mounts  
1 x 16mm firerated flush plasterboard

Floating Timber on 3mm A-mat    Bare Floor  
**L'nT,w**    **56**    **59**  
**C<sub>i</sub>**    **0**    **0**

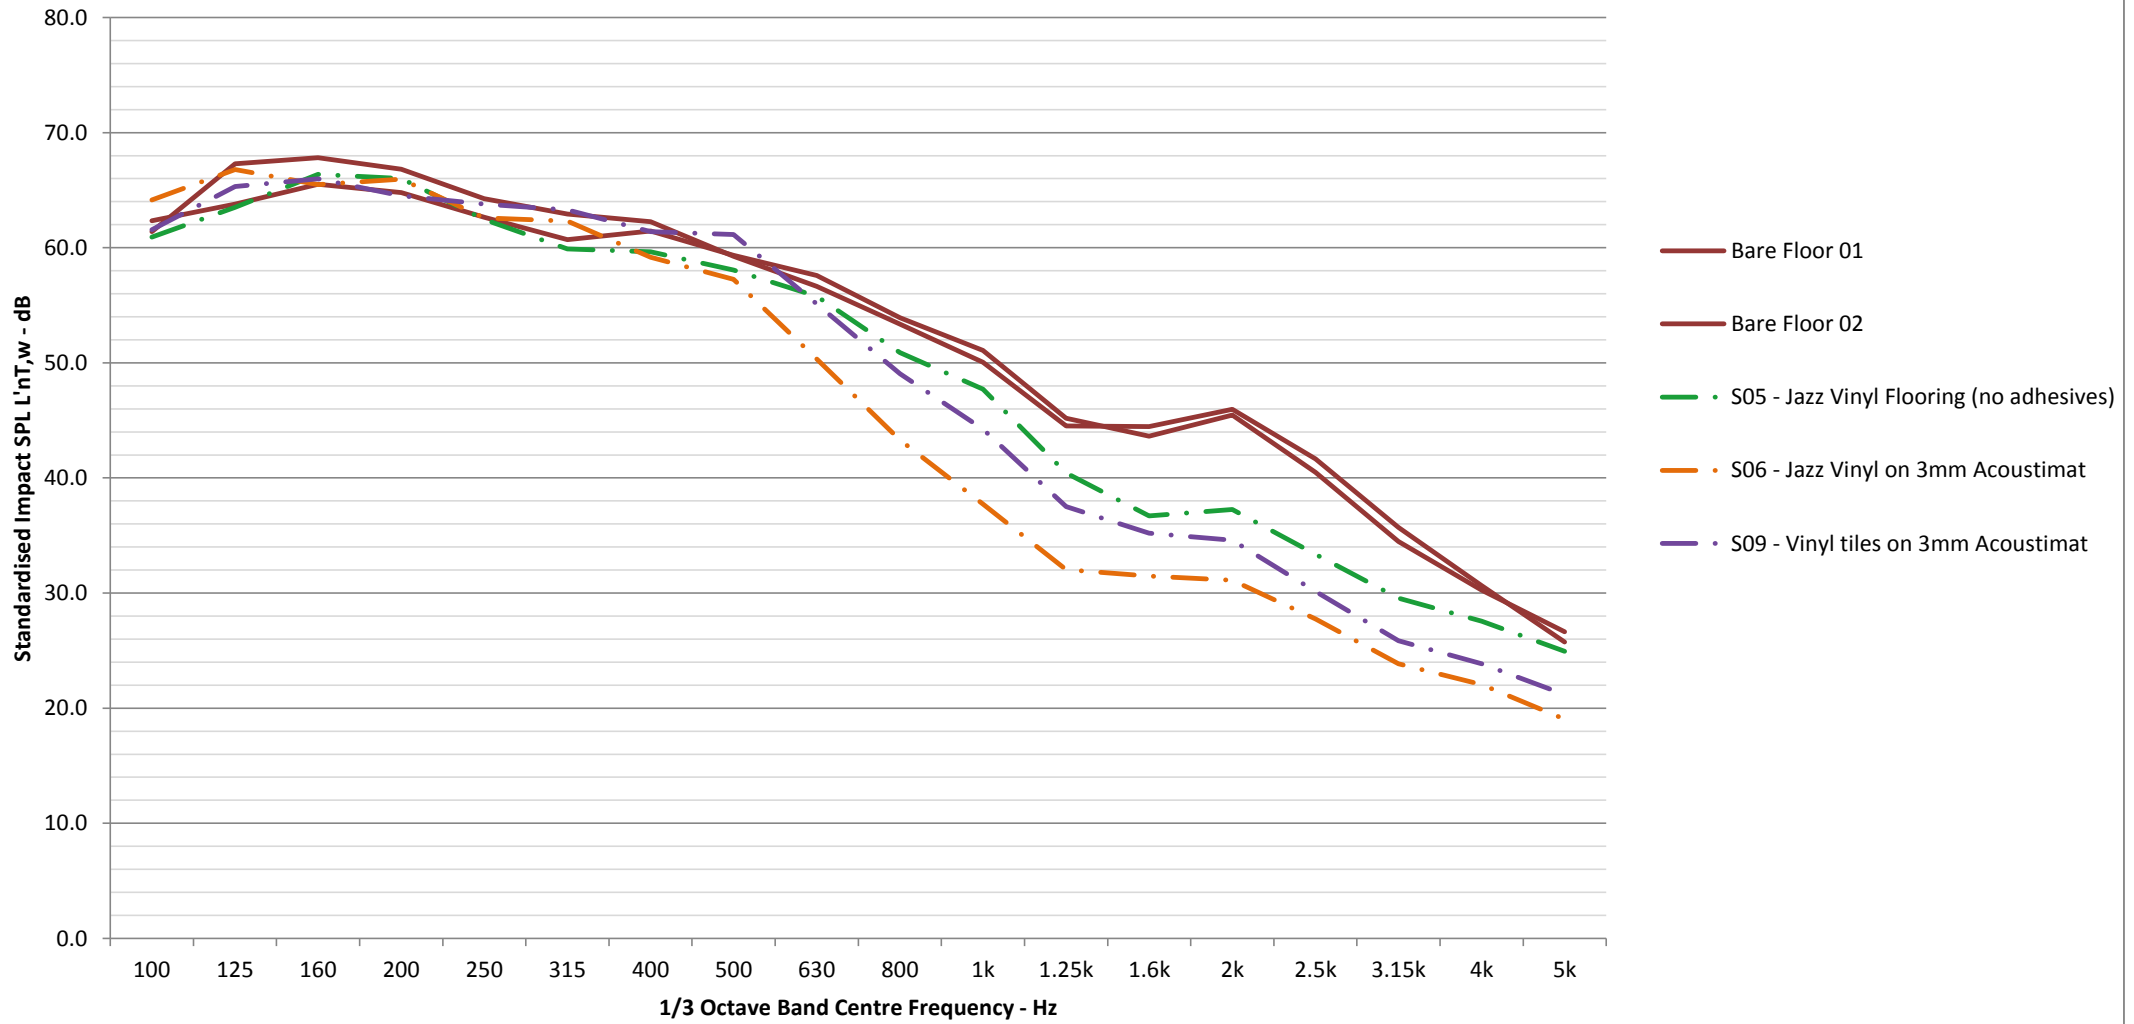
## Sample Comparison - Vinyl Samples
